AVIATION INVESTIGATION REPORT

A01P0194

COLLISION WITH TERRAIN

DE HAVILLAND DHC-2 C-GVHT

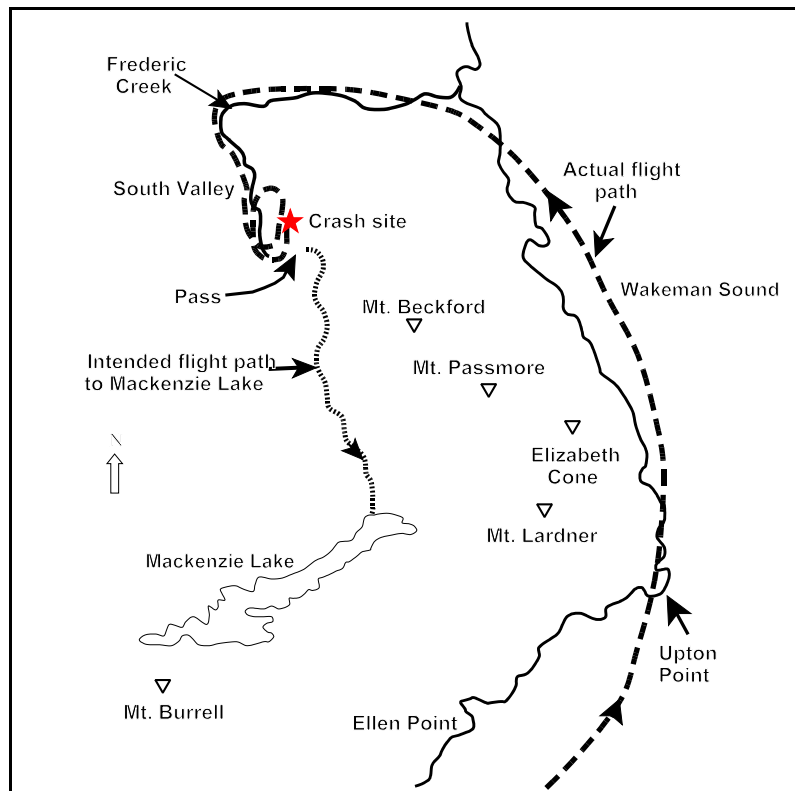
Figure 1 - C-GVHT's flight path

One of the managers of the camp, who was on a logging road in the south valley, advised the pilot to come to the Frederic Creek area because it was clear of cloud. The pilot then flew northeast to Wakeman Sound, where he advised that he could descend below the cloud to the Frederic Creek inlet. The aircraft flew west along Frederic Creek until turning left toward the pass in the south Frederic Creek valley. The pass crosses a north-south divide (saddle); the valley to the east of the divide turns south immediately and descends to Mackenzie Lake. (See Figure 1.)

The aircraft flew south toward the pass and made one circuit of the valley. After the circuit, the aircraft again flew toward the pass, then executed a sharp left turn about 10 seconds before the accident. The aircraft was flying away from the pass at impact. The last brief radio transmission from the pilot was at 1706, only seconds before impact.

During the second attempt, the turn radius was smaller and the ground speed slower than in the first circuit, allowing the aircraft to come closer to the pass. As a result, the aircraft was forced to turn in a more confined area.

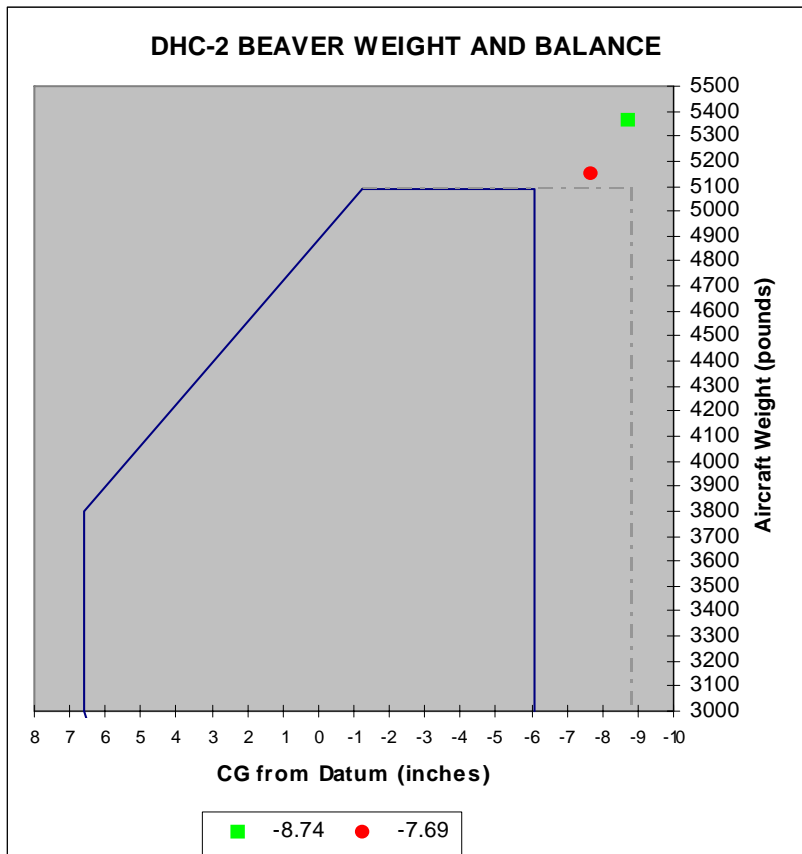
The pilot loaded the aircraft at Campbell River himself, as was his practice. There is no information that the cargo or passengers were weighed before the flight. Weight and balance calculations by TSB, using actual weights of the occupants and cargo carried, show that, at take-off from Campbell River, the aircraft was 5364 pounds, with a CG of 8.7 inches aft of the datum—274 pounds over MAUW and 2.6 inches outside the aft CG limit. Calculations also showed that the aircraft was overloaded by approximately 59 pounds at the time of the accident and that the CG was 1.6 inches outside the

aft limit. (See Figure 2. Note that this graph also shows the aft CG limit for the wheels configuration.)
